Review of a Building survey on a Grade II Listed property, Originally built as a Dovecote

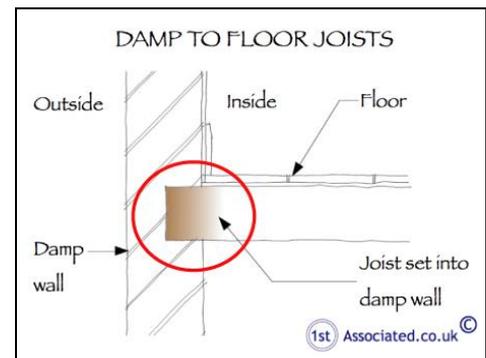
Damp to floor joists can be
expensive to repair

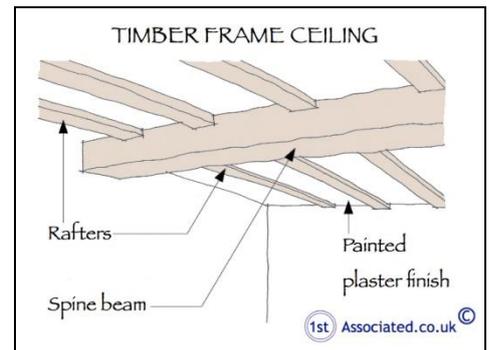
The property had exposed timber ceilings all the way to the roof, which was a feature that really appealed to our client and was a major factor when deciding to purchase the property. It was also decorated to a very high standard internally, which also appealed.

Timber beams

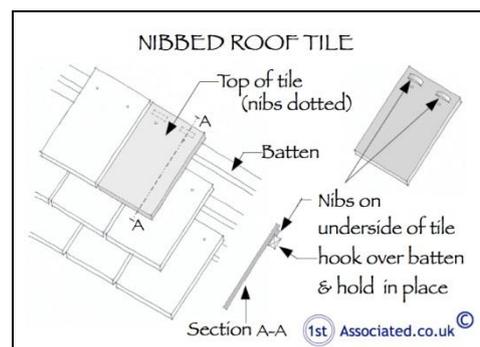
Example of a nibbed tile

The nibbed tile roof had many displaced and spalling tiles and much of the roof was covered with a mass of moss and lichens. To re-roof the property would be very costly, especially as scaffolding would be needed to access it which can prove to be expensive.

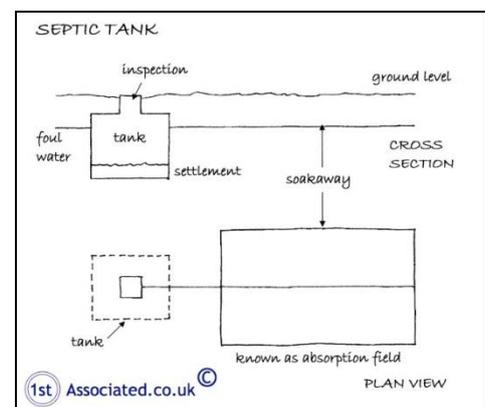
Septic tank

possible septic tank which had not been drained for many, many years.

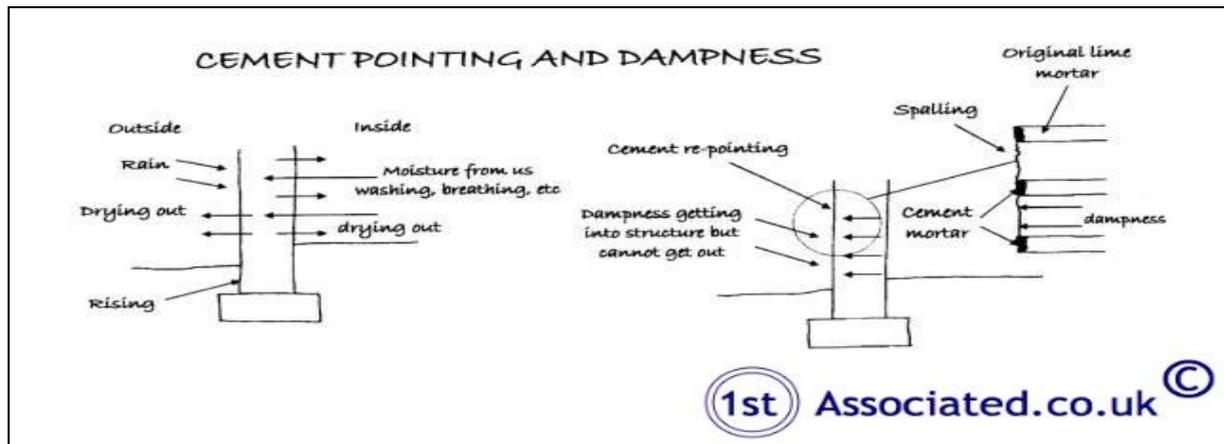
There were numerous other costly problems with the property too, i.e. spalling brick walls, wrong mortar used (they had used cement mortar when an old property like this needs to breathe otherwise there is a greater risk of condensation, so a like mortar is always advisable), leaking gutters and downpipes, signs of woodworm and a

Use lime mortar every time instead of cement mortar
to allow the property to breathe

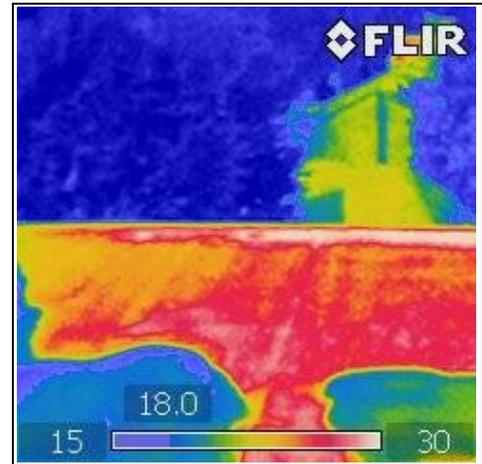
We often carry out thermal imaging too. The red areas in the photo show heat loss from a part of the property, in the adjacent photo you can see heat loss from the roof.

Thermal image showing heat loss out of a thatched roof
